ST PETER & ST PAUL COSGROVE

"THE STORY"

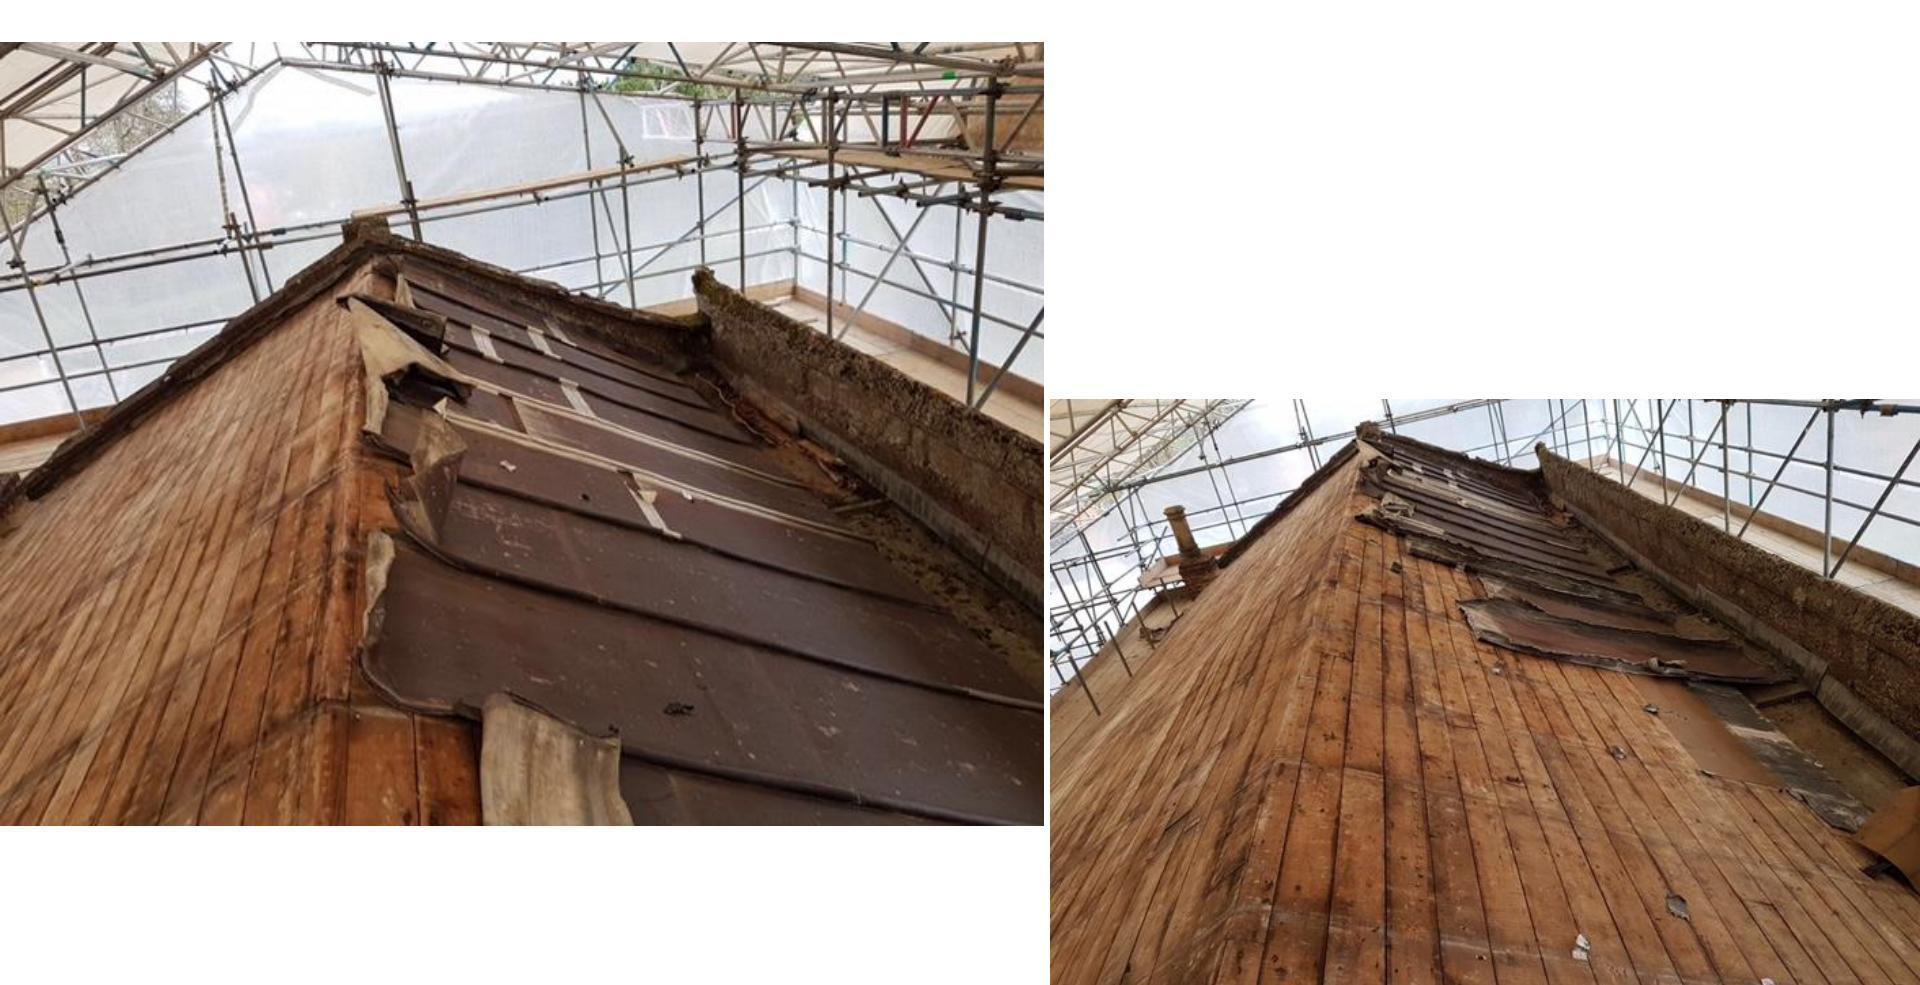
Stripping old lead from Nave and Gutter

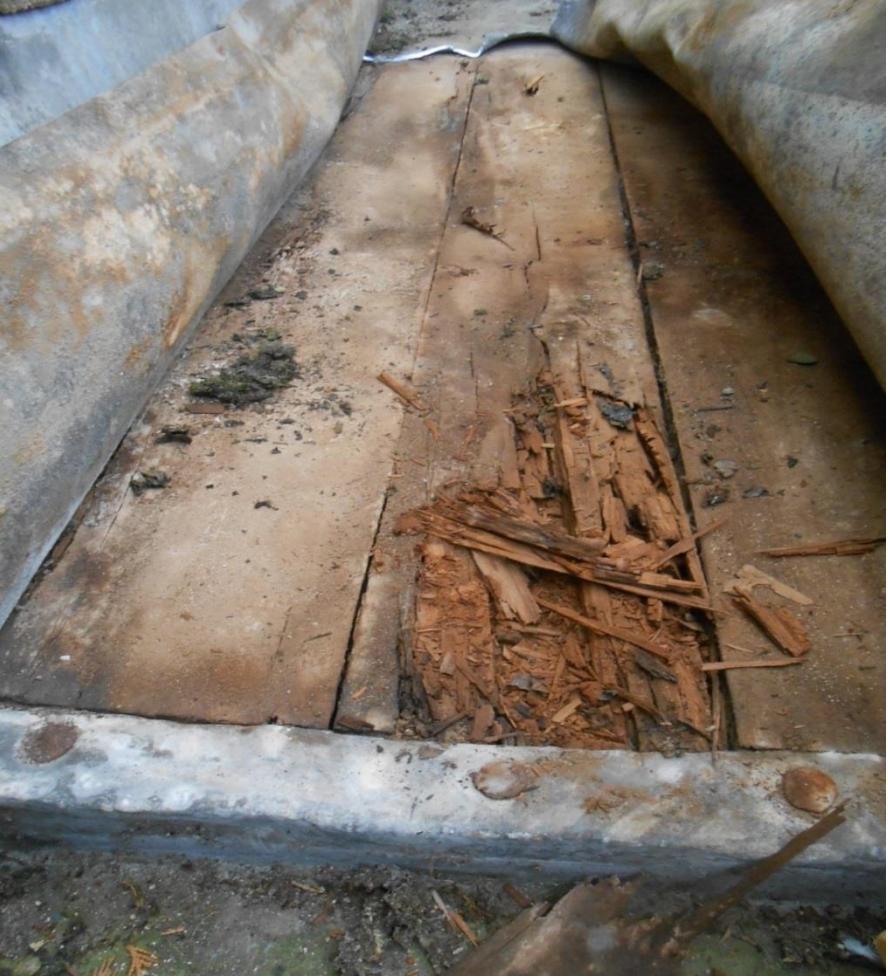
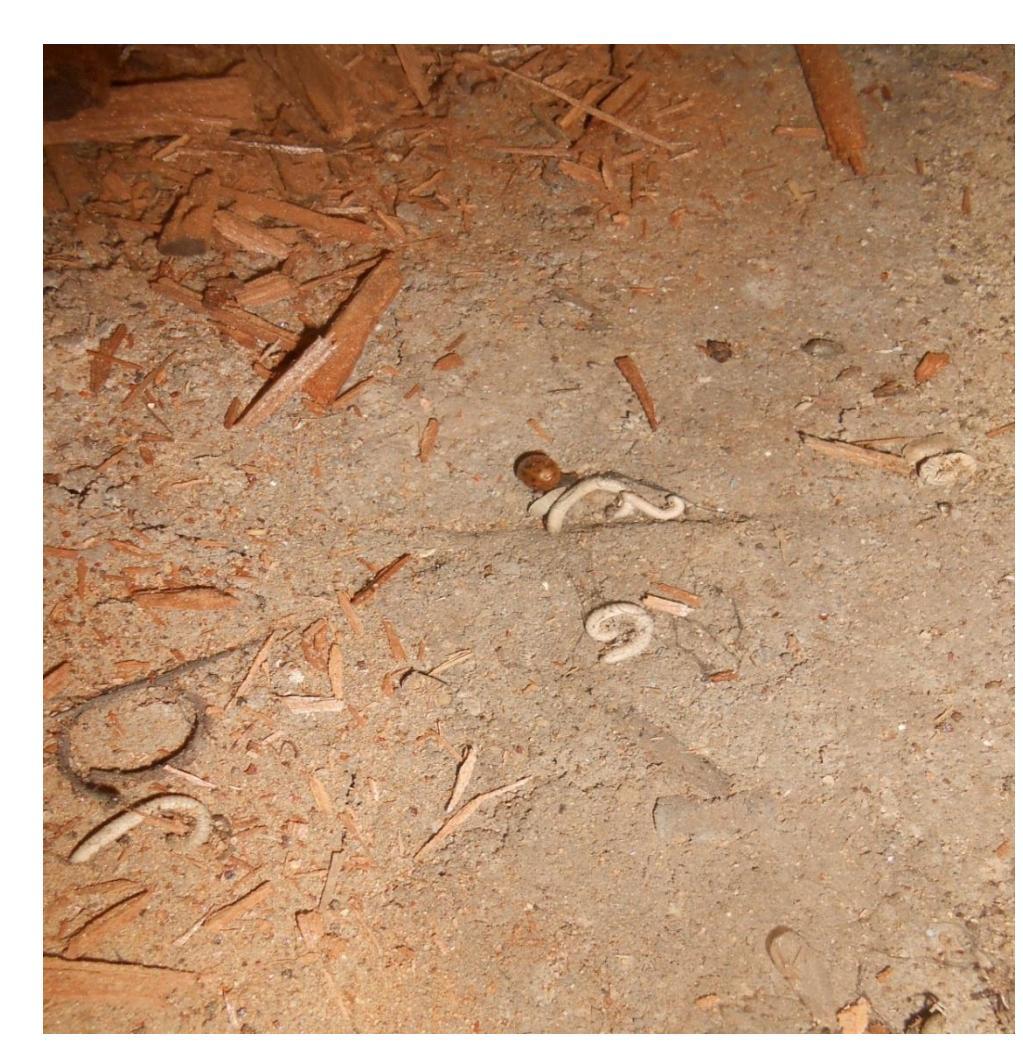
Removal of lead to Gutters, white worm found.

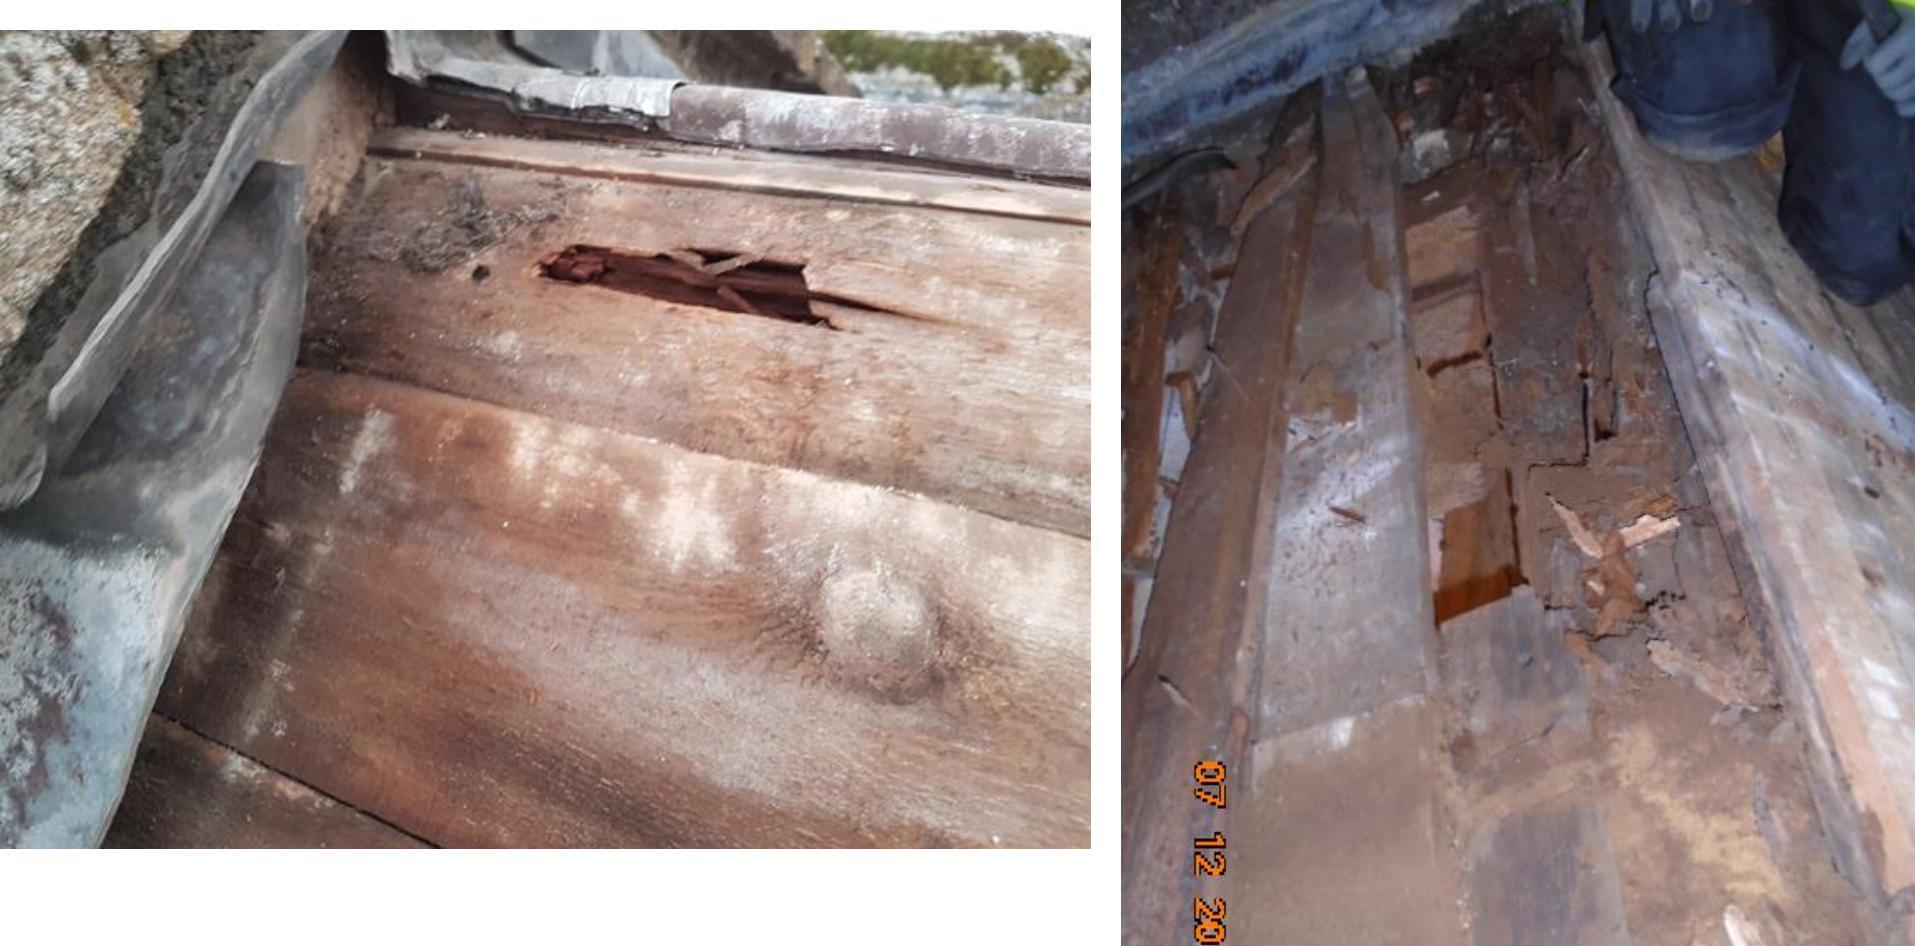
Removal of lead, reveals decayed boarding to the ridge. Inspection of timber required urgently.

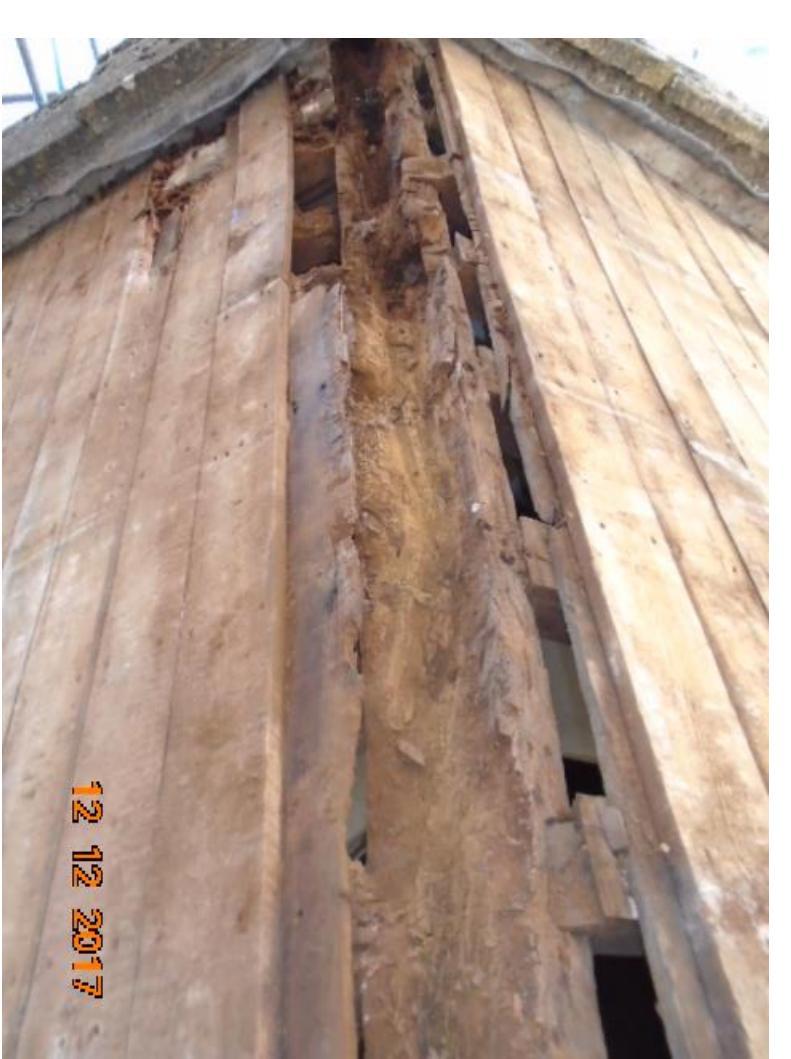
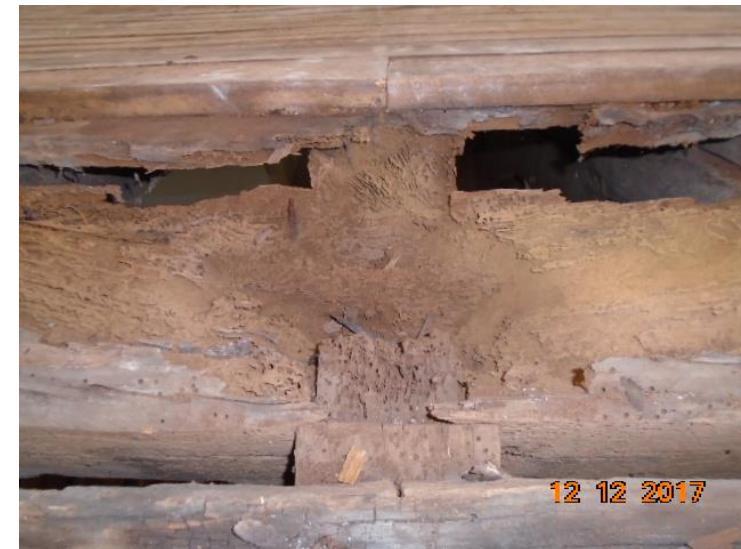
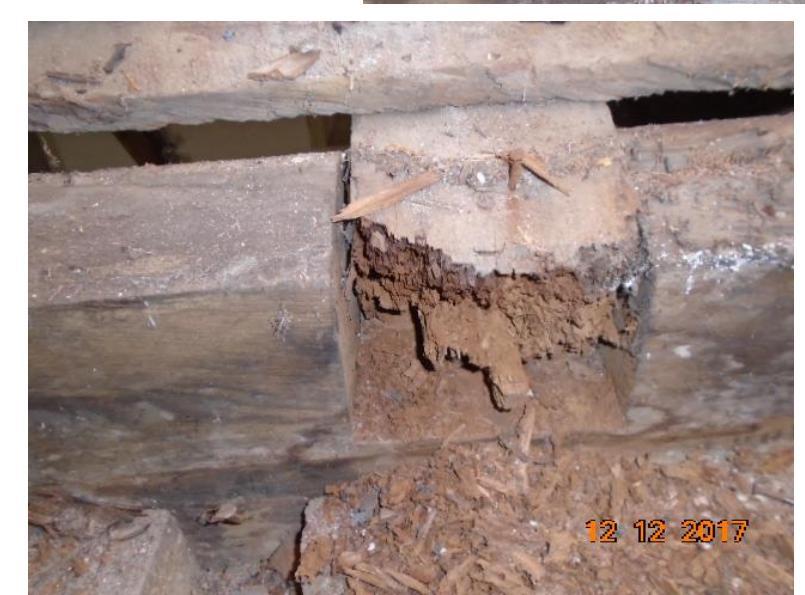
Ridge/Rafters timbers need replacing. Following extent of repairs required, the church was then closed.

- Once the rotten boarding was found, removal of the full ridge timber had to happen, there was no strength or bearing of the roof structure as a whole.
- It soon became apparent that water penetration had made the timber very damp which in turn became a haven for deathwatch beetle.
- Over the years the deathwatch beetle has been eating away the roof timbers

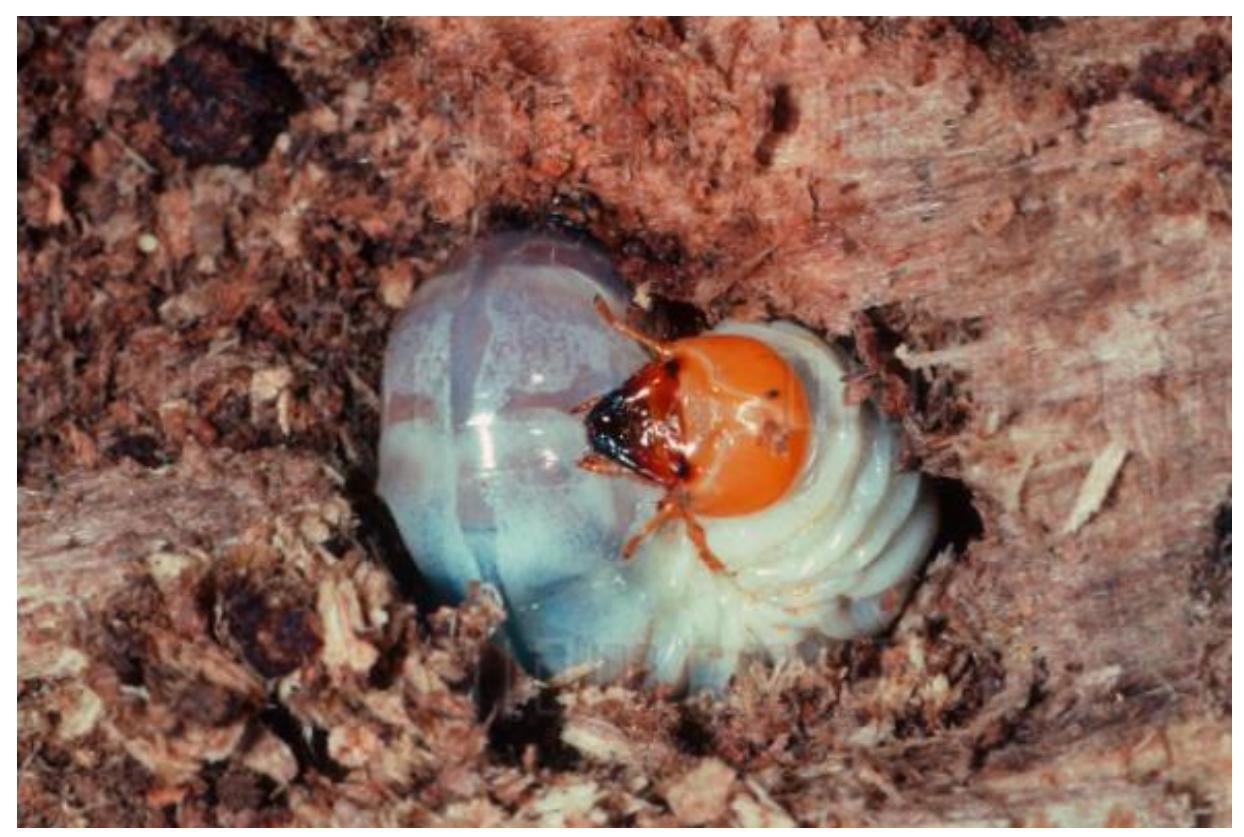
Larvae eating timber

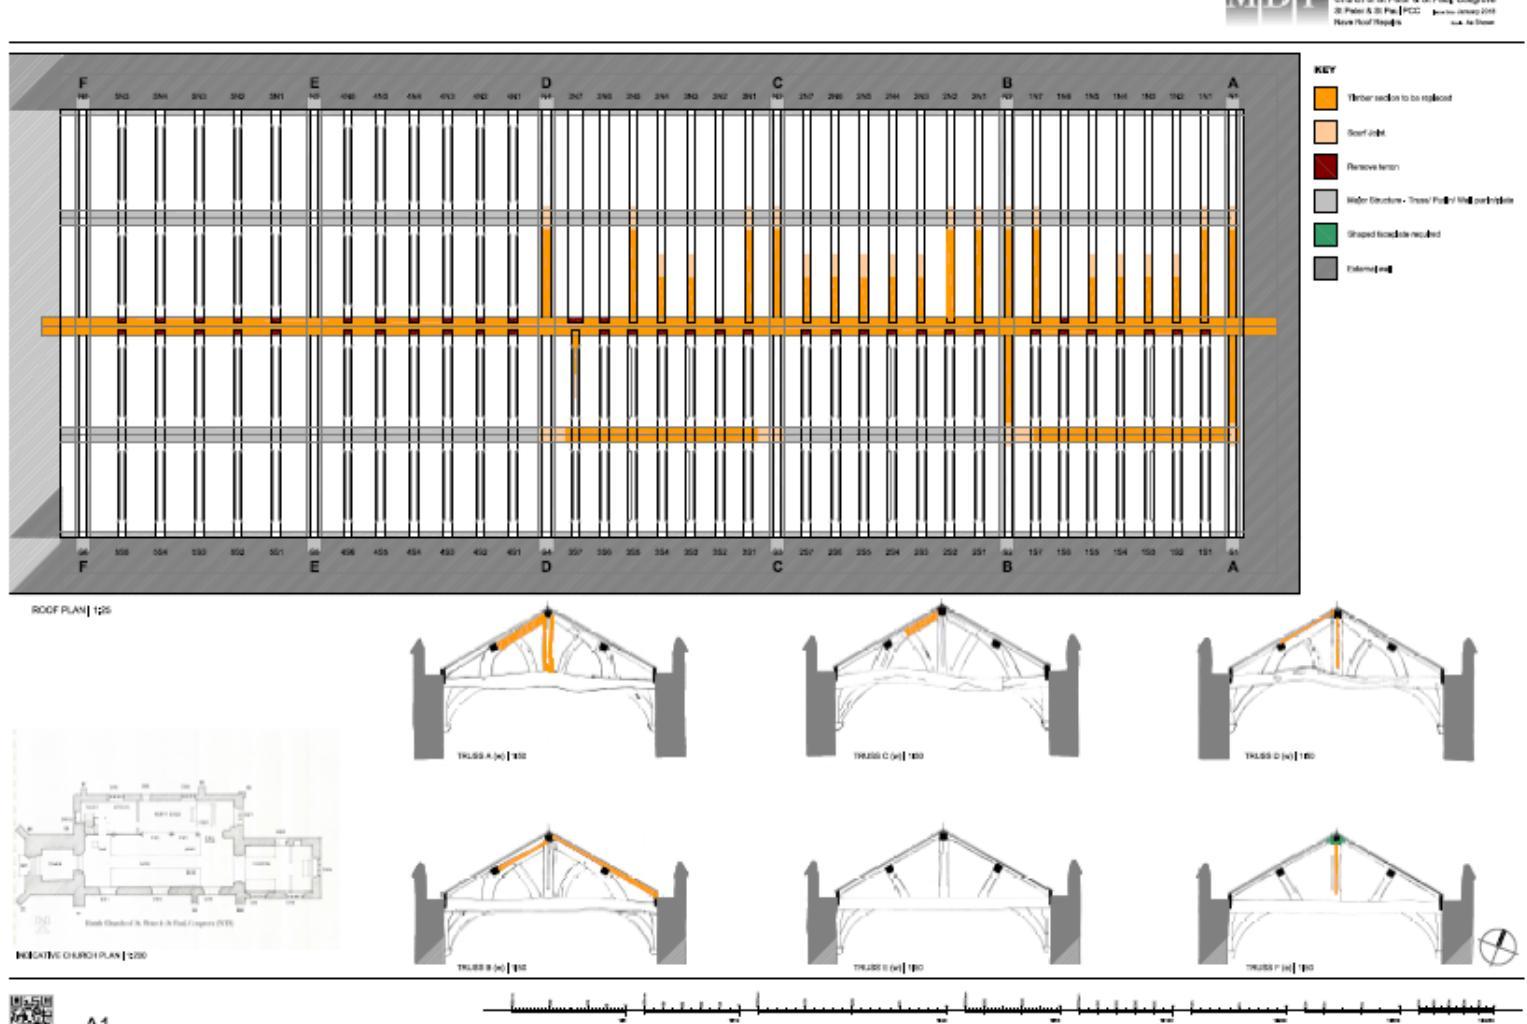
- Three sets of drawings were issued so that CEL had to produce the most cost effective way with a very careful approach not to remove to much of the historic timber.
- It was found that in 1932 the roof was over boarded with a much wider board fixed over the original boarding.

Design team issue details of repairs required

- 5 x Main oak ridges (approx. 4.5 long)weight approx 475kg each
- 12 x Full rafter replacements (with carving)
- 2 x Full Purling's (with carvings)
- 11 x Half scarf rafters (with carvings)
- 2 x Wind braces
- 2 x Large truss end sections
- Vast amount of replacement under and over boarding

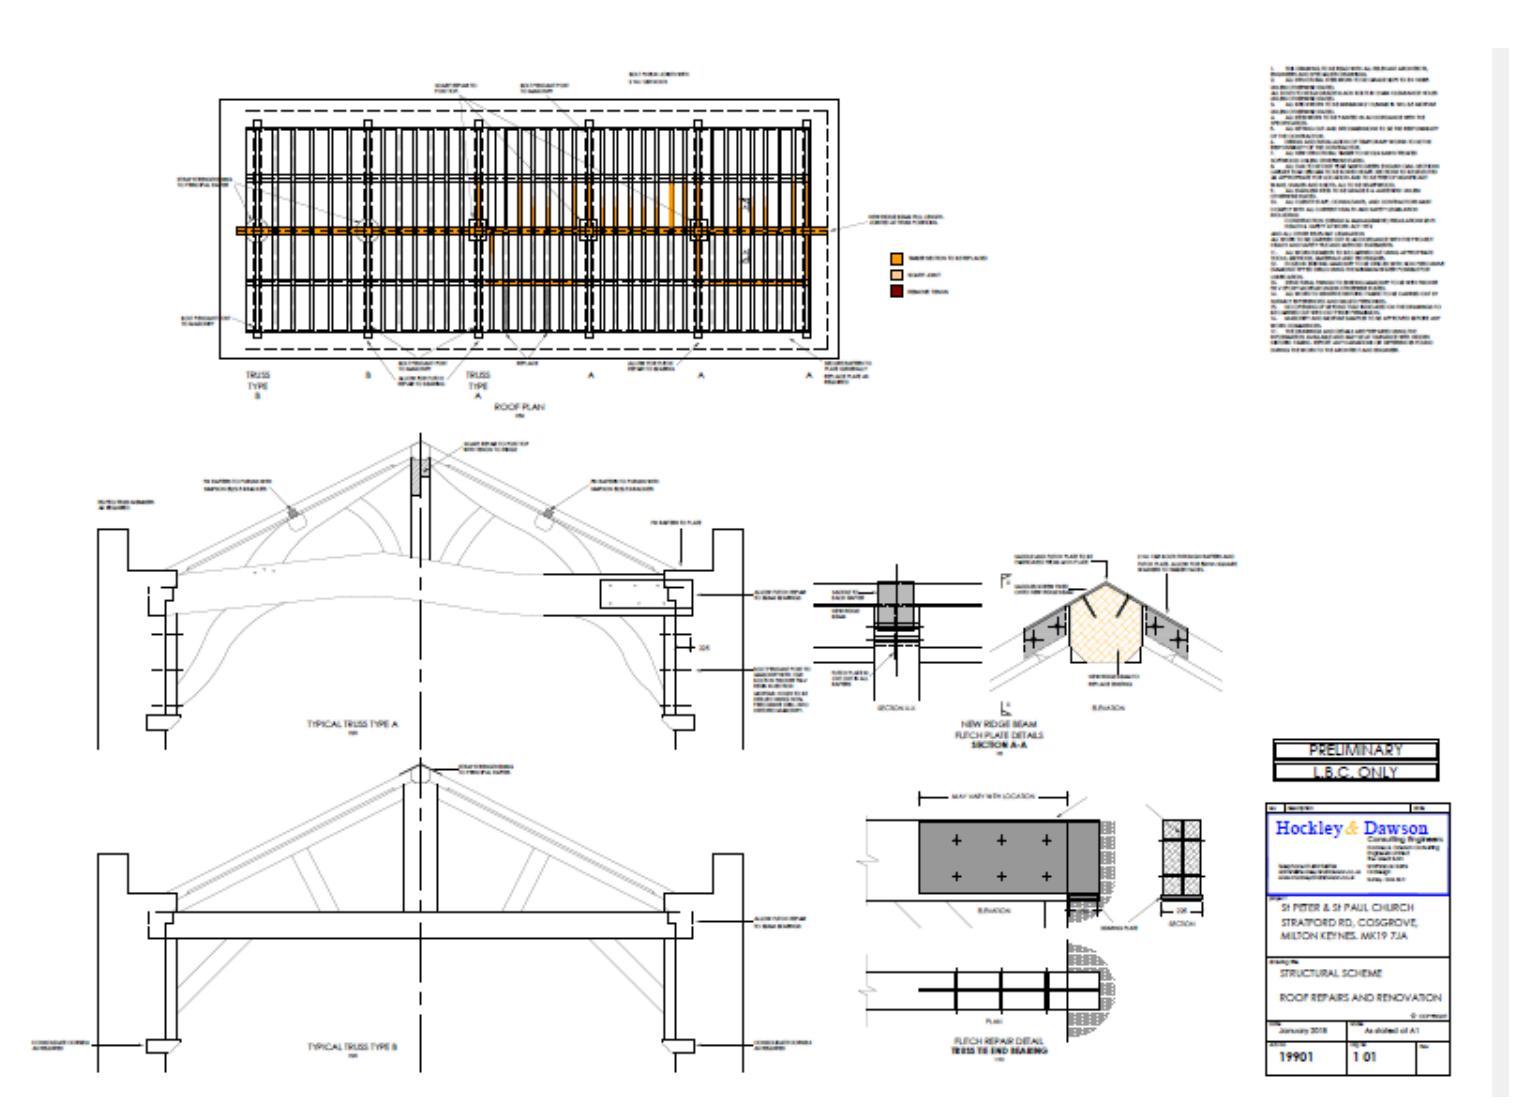
Structural Engineers details

- 58 x Rafter plate fixings had to be made to install at the end of rafter to ridge
- 6 x steel plates had to be made and installed to the truss ends
- 24 x 16mm stainless steel bars had to be drilled and fixed to the Truss support base post
- Large vertical half laps had to be inserted to the king post
- 24 x Ridge plates, bolted over ridge on to rafters

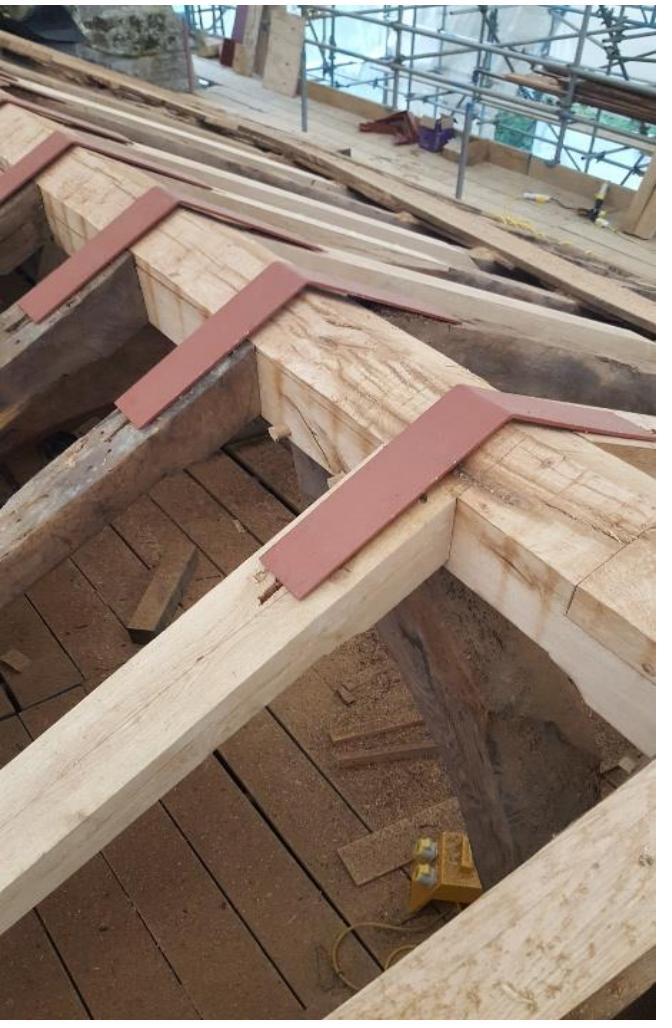
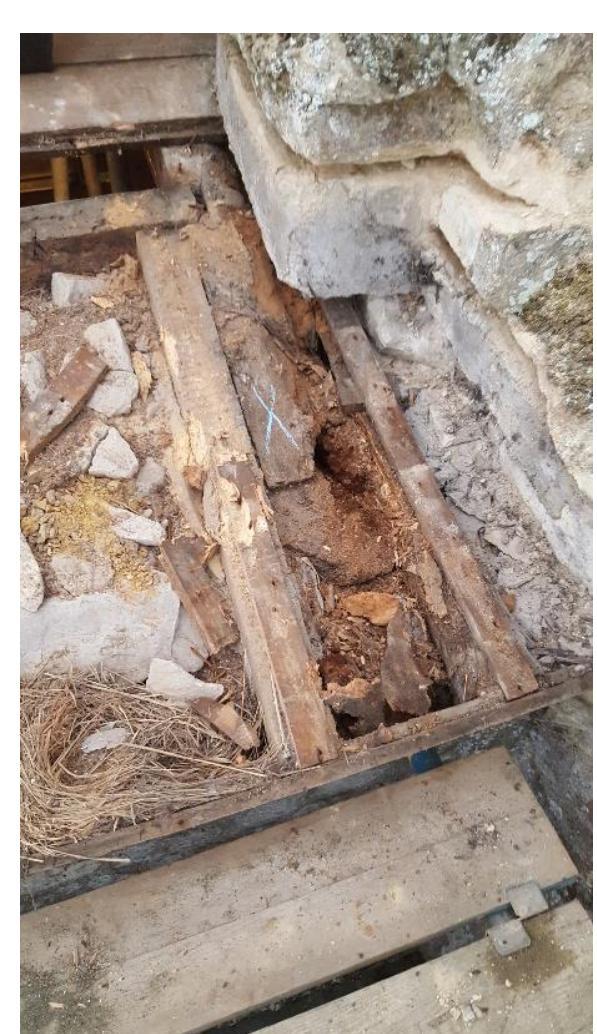
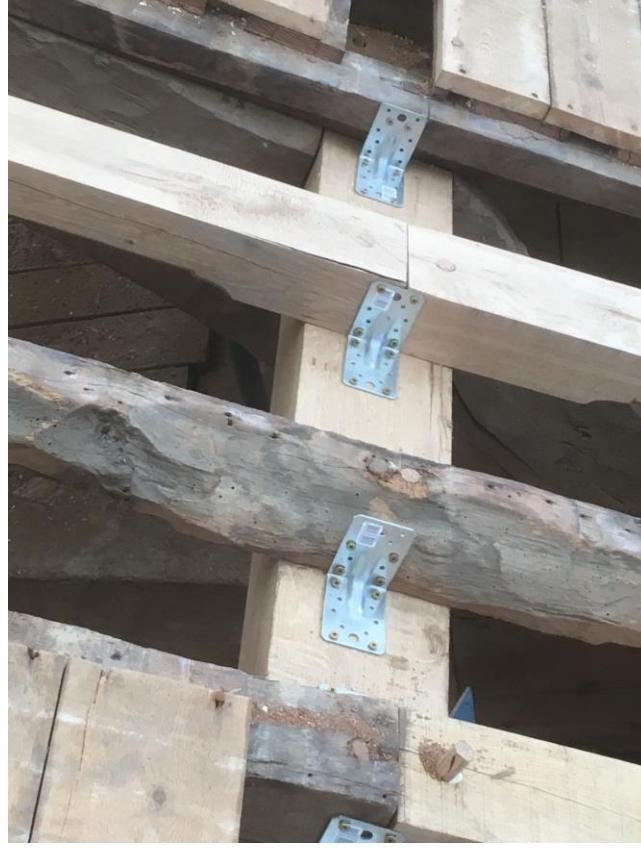
Structural plates installed to support the new rafters.

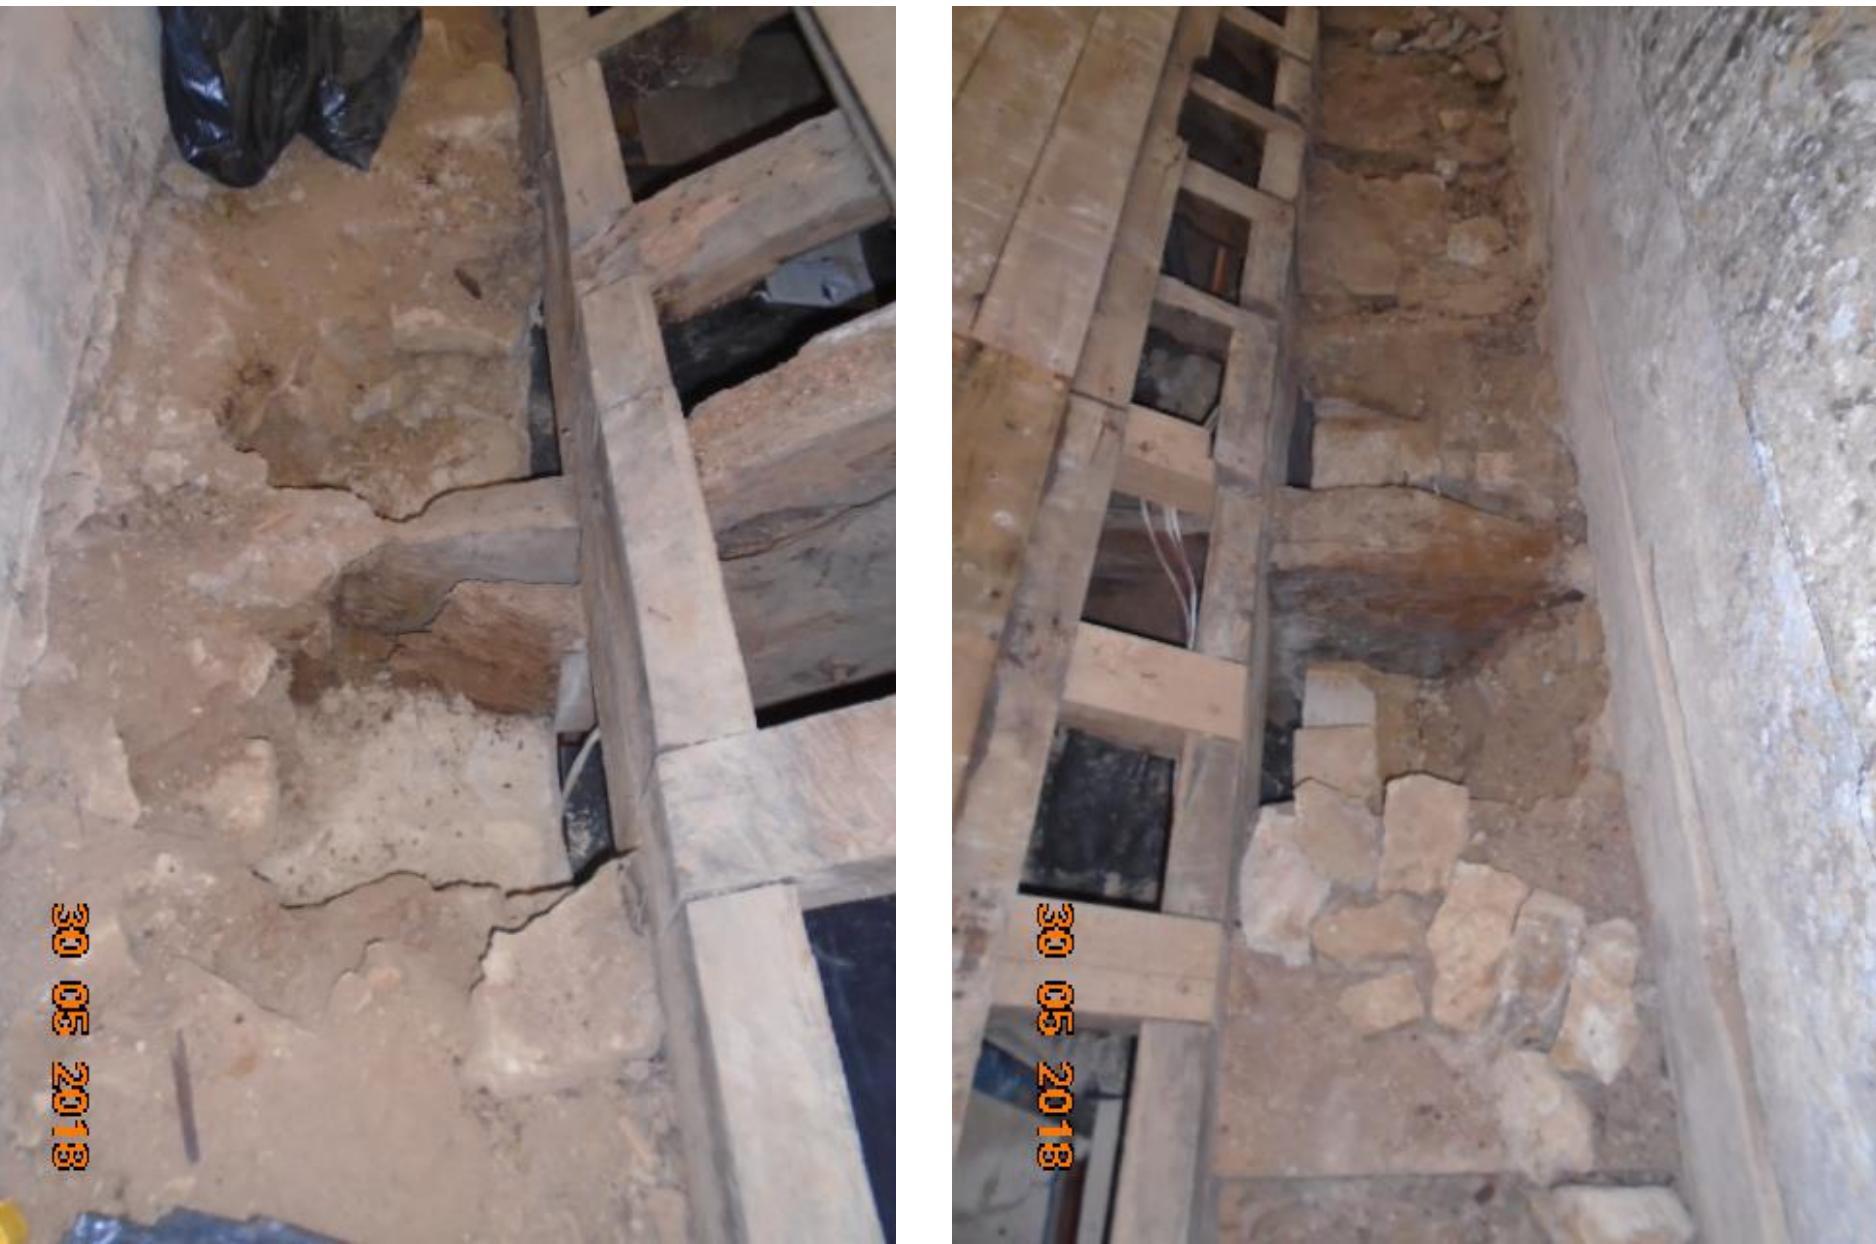
No bearing to the truss ends

Steel plates had to be installed to the truss ends.

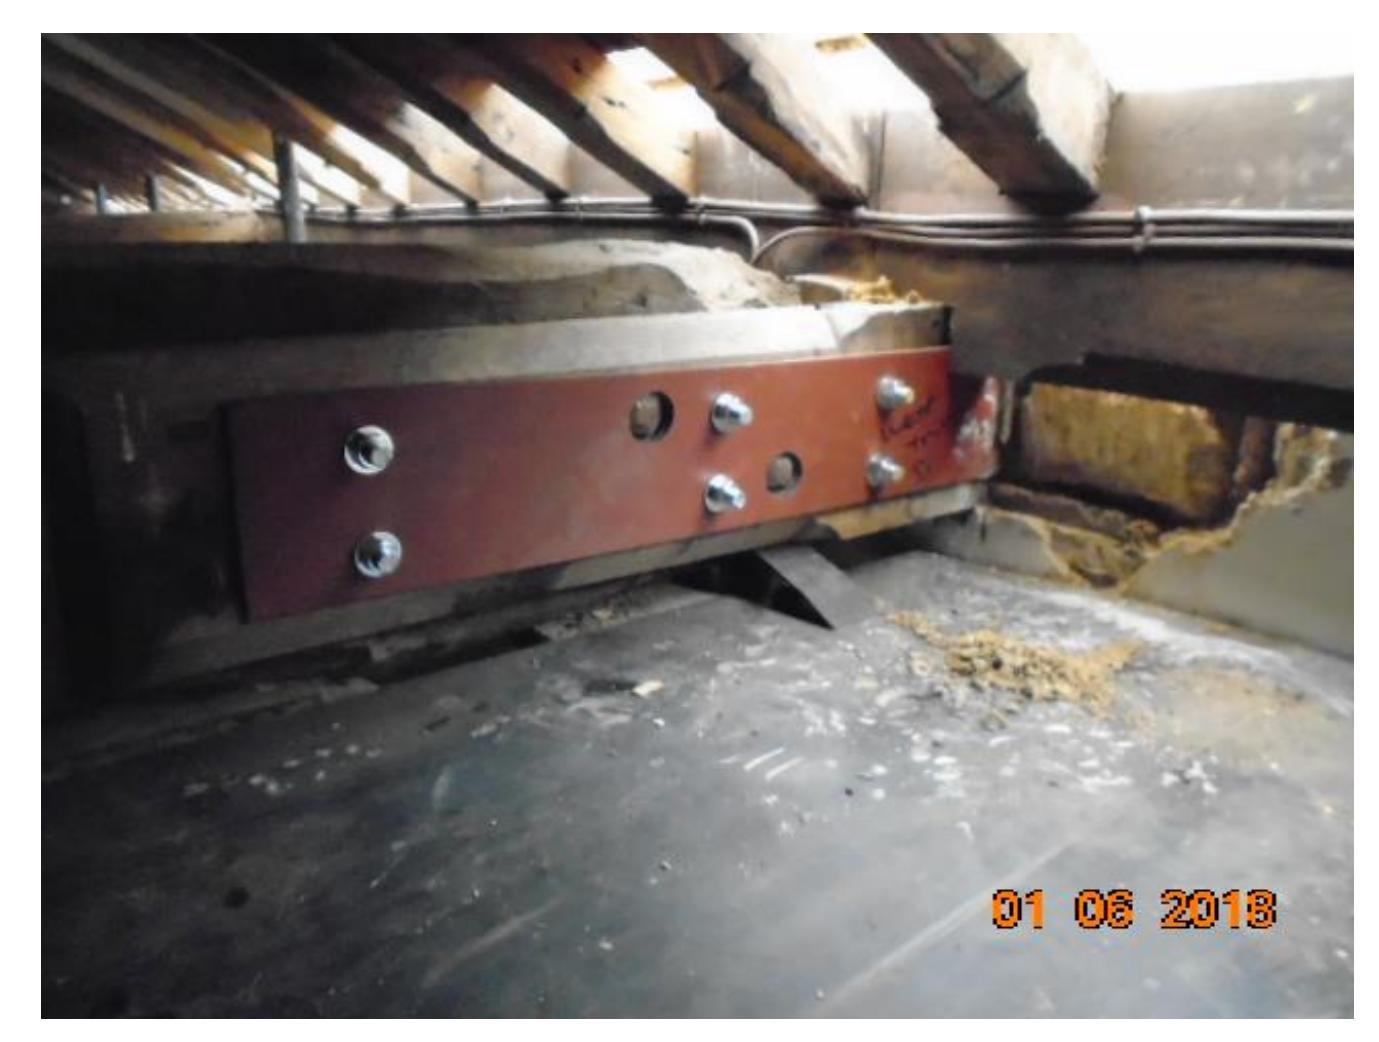
Steel plates 6 large, 10mm thick mild steel plates had to be installed with 18mm bar

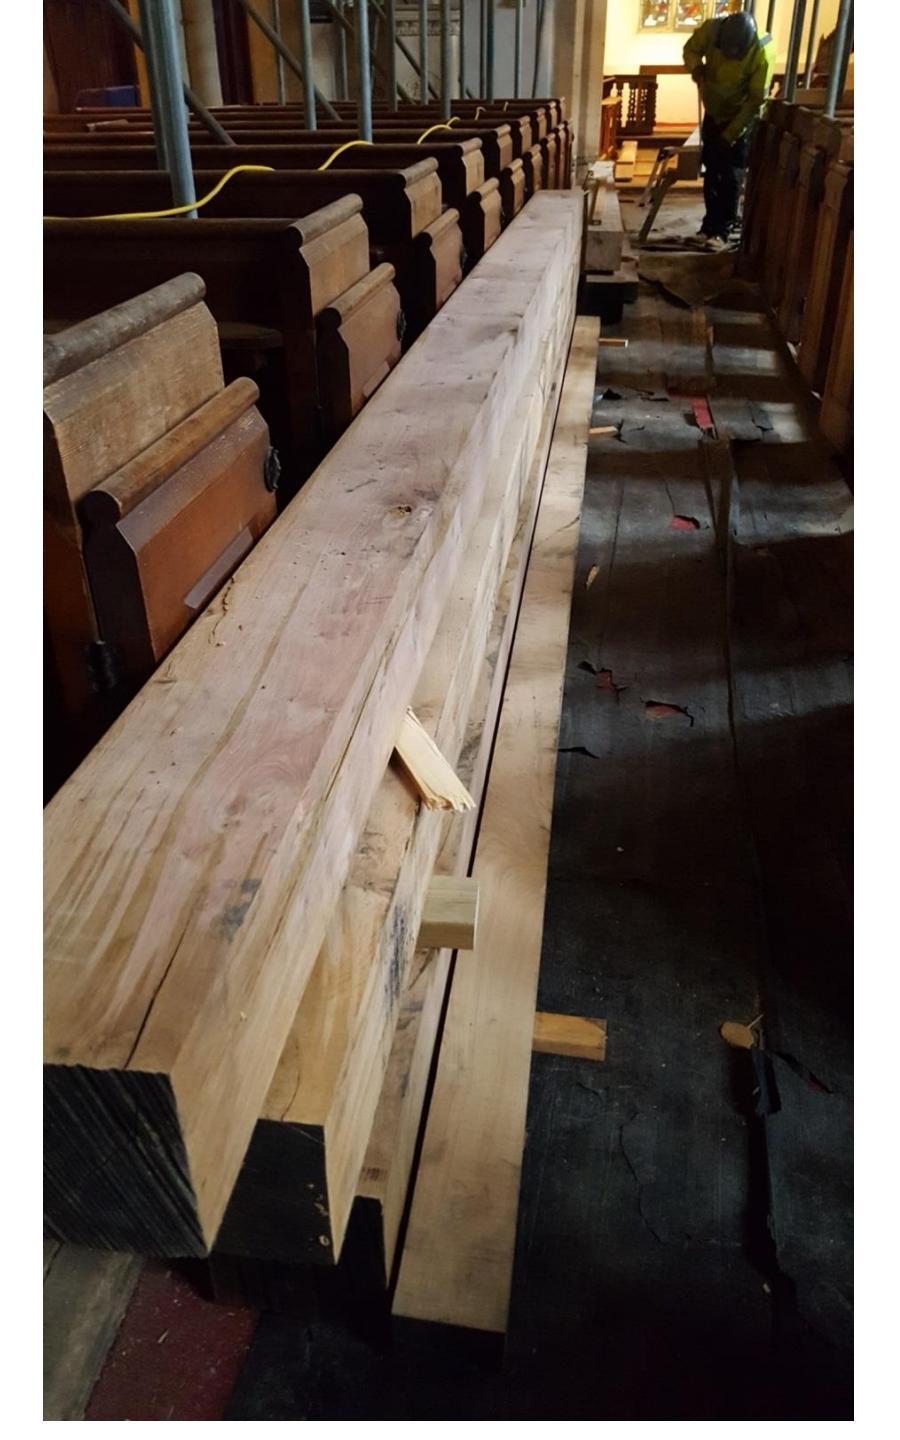
Full ridge timber replacement was required

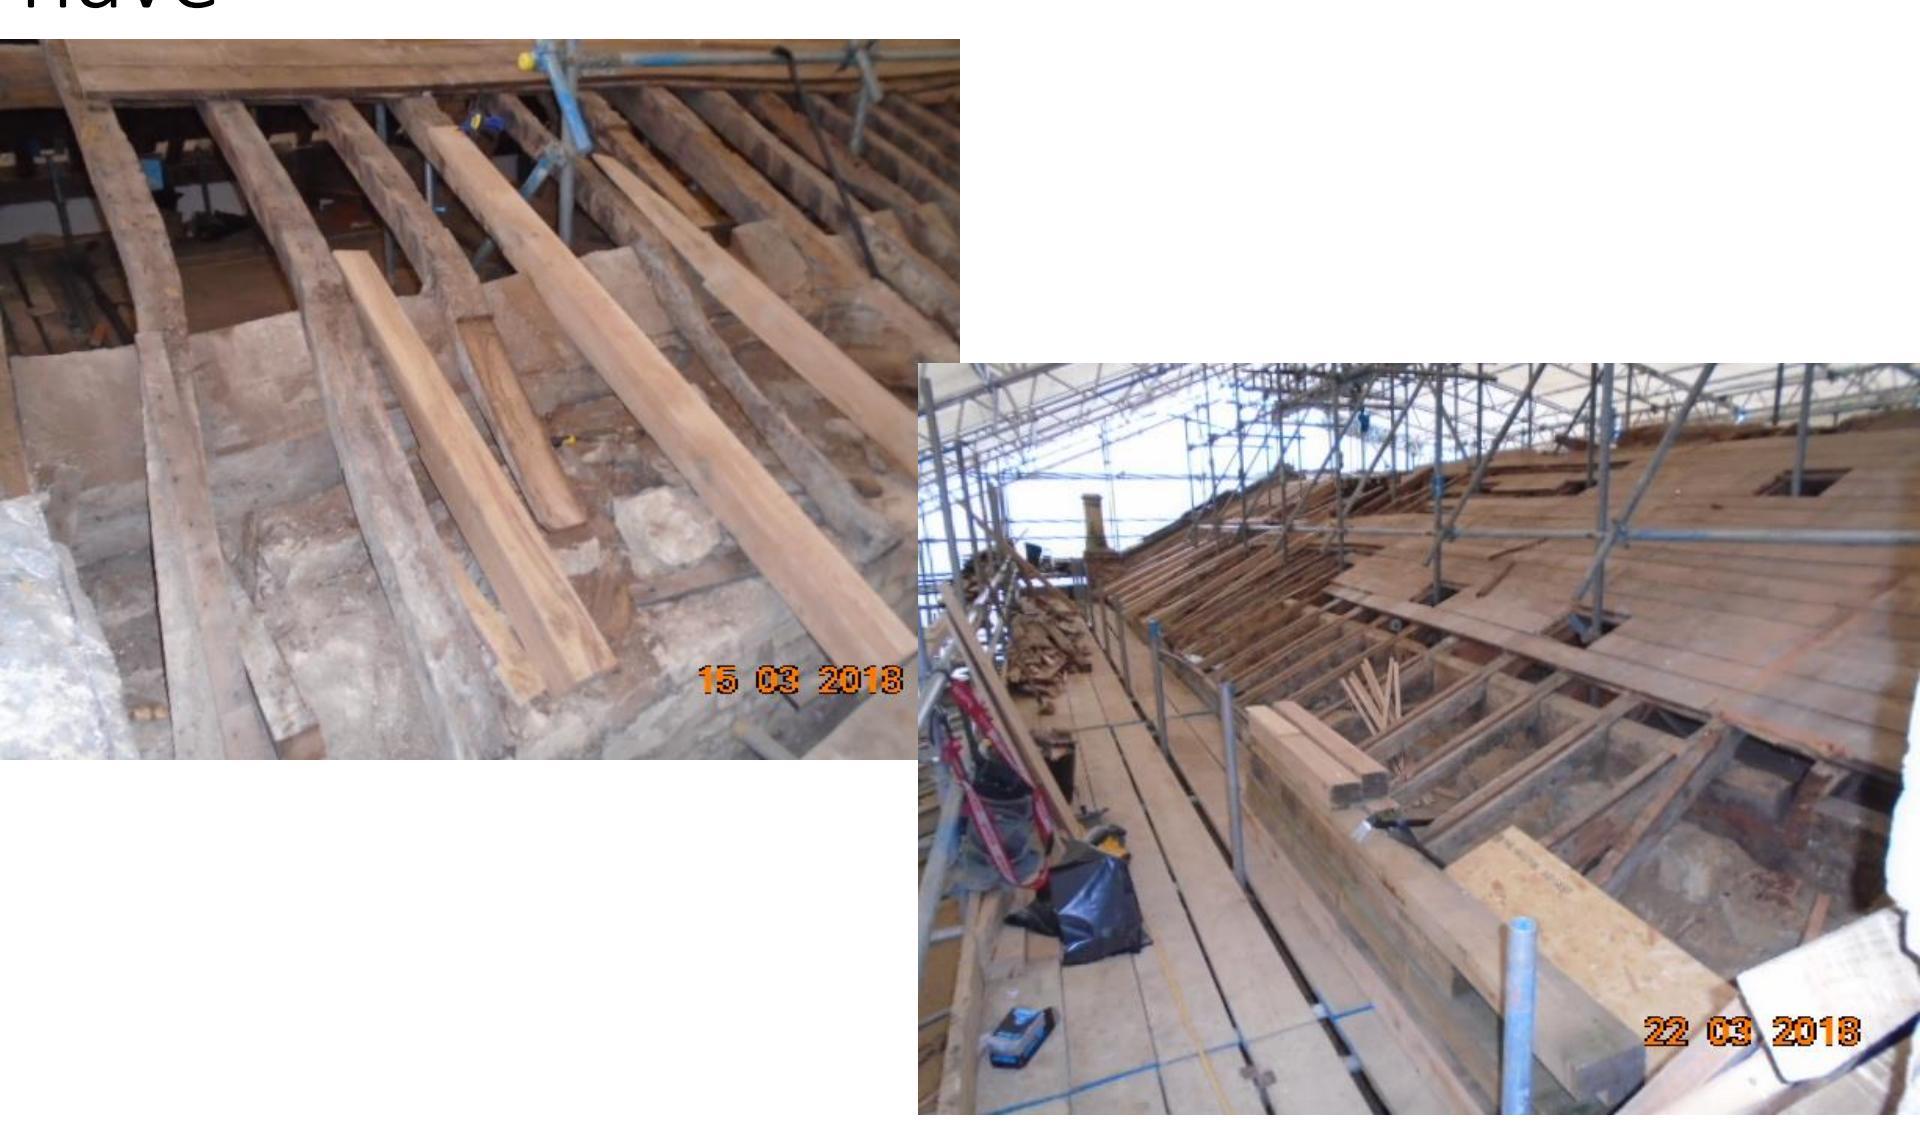
No structural bearing to rafter ends, no ventilation to rafter ends to the south side of nave.

Following a visit by the design team, urgent repairs required to the South side of the nave
