ST PETER & ST PAUL COSGROVE

"THE STORY"

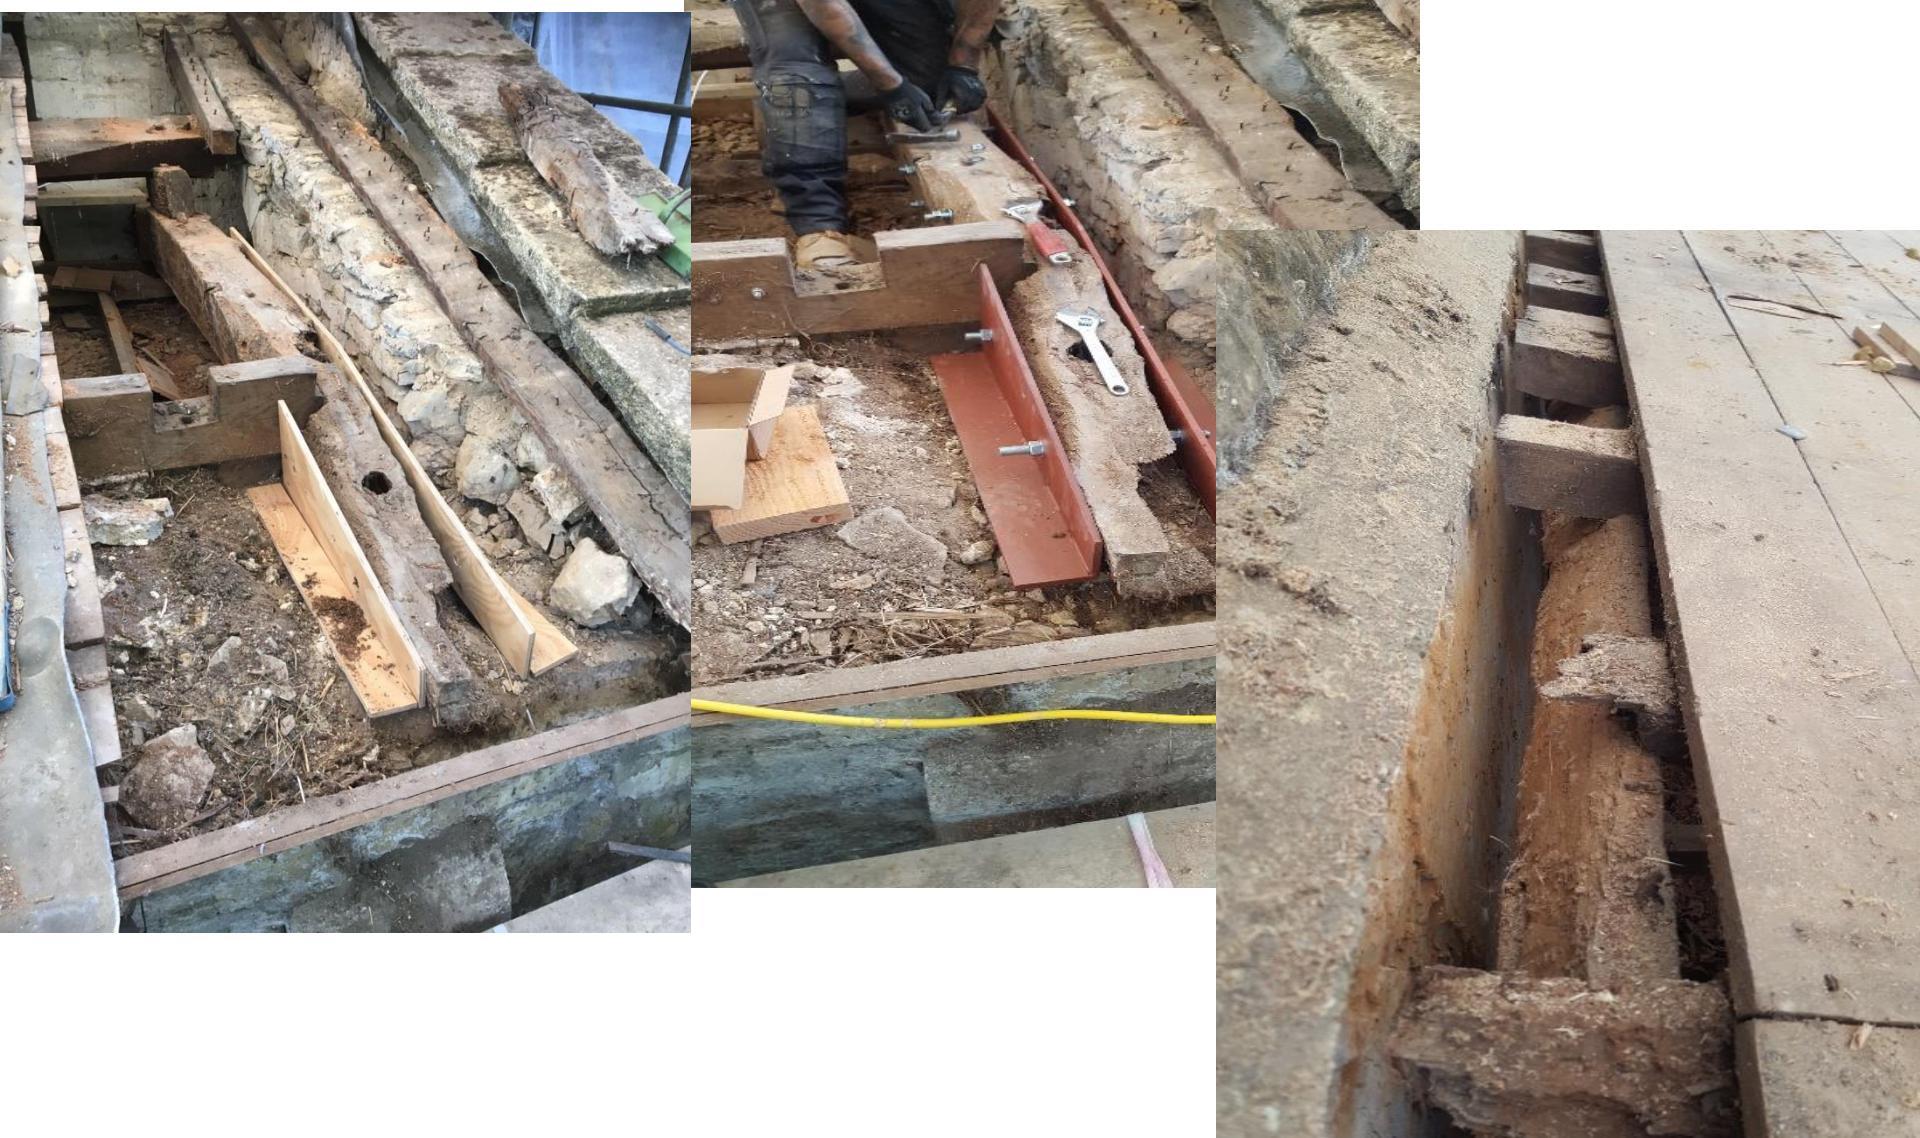
Structural works required to South of Nave

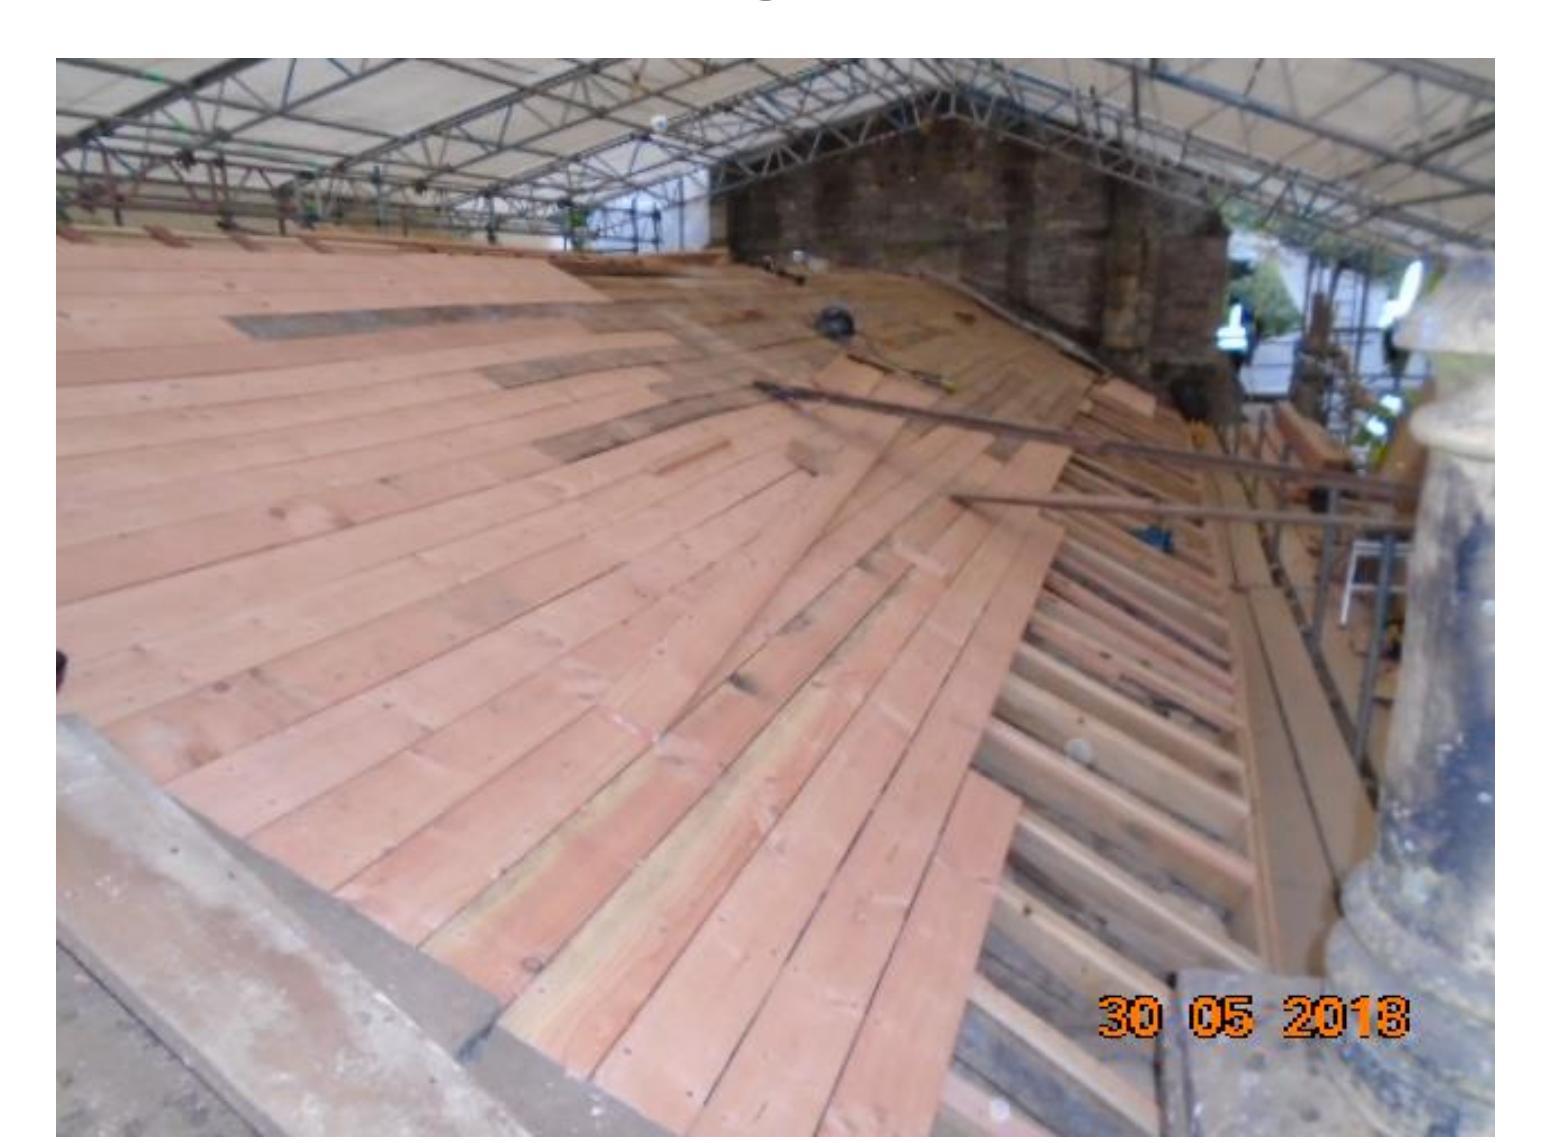
Structural works complete, followed by new over boarding to the Nave.

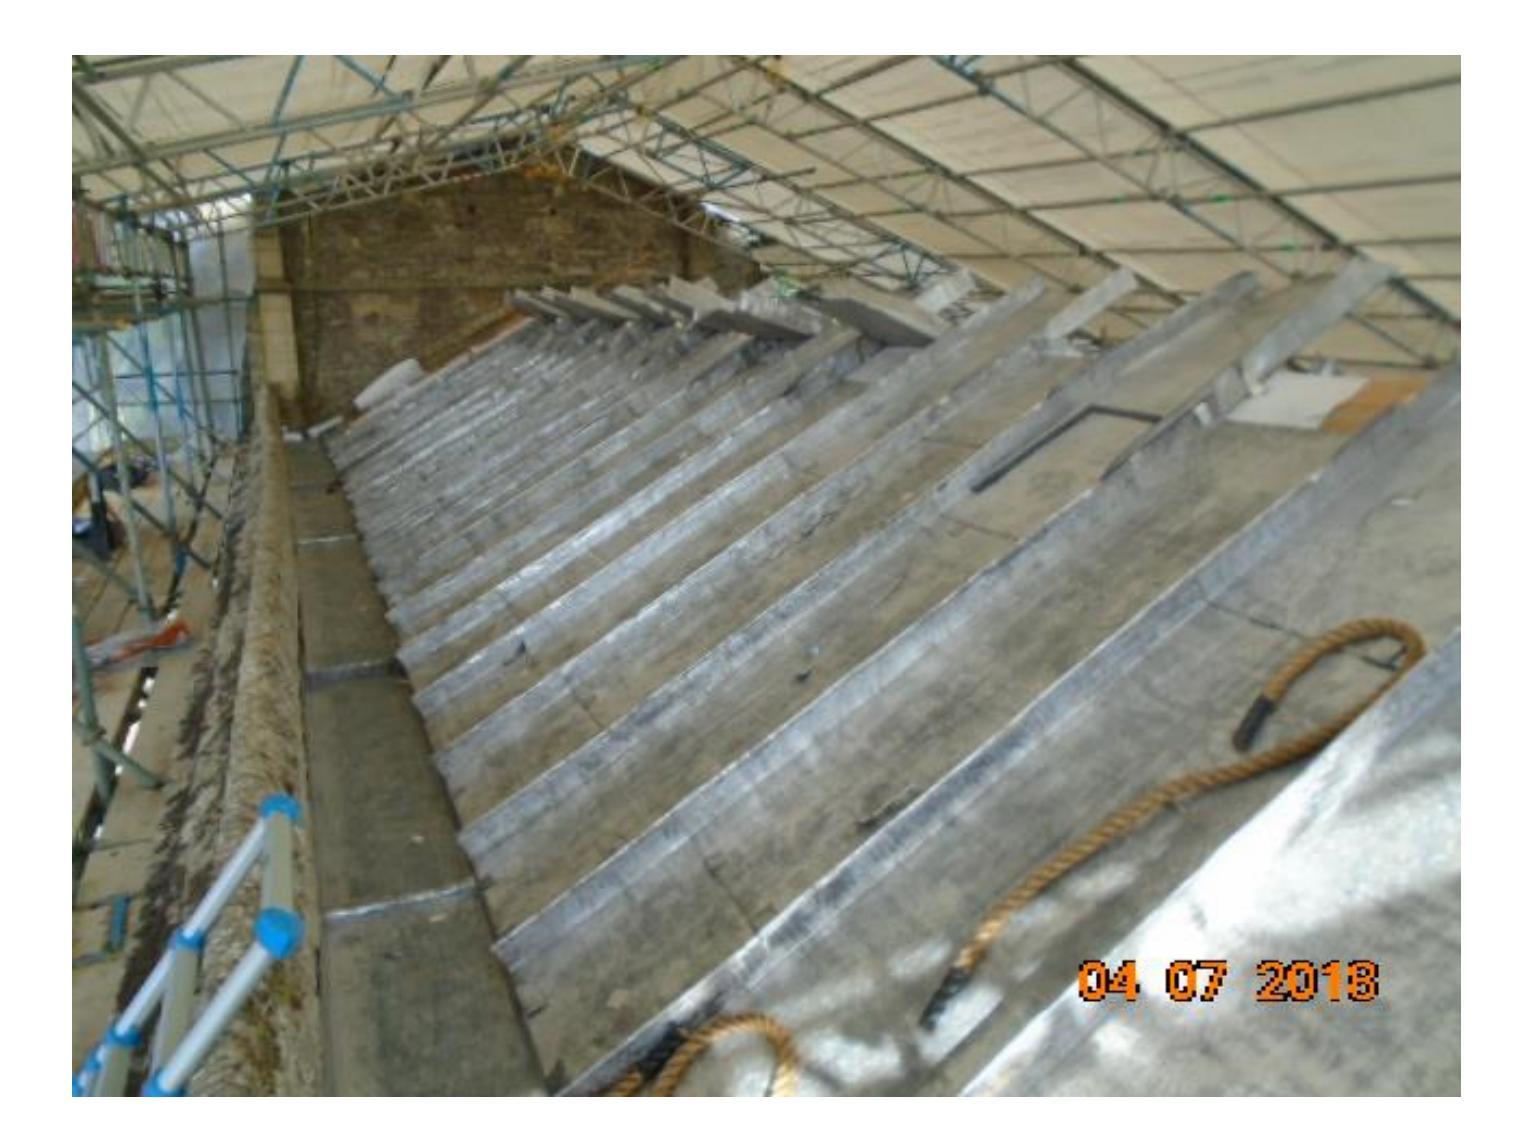
Your lead has been recast and re-laid

- Lead that was removed from various areas was taken back to our casting shop and re-cast, brought back to site and laid.
- Gutter lead was Code 9 which weighs approximately 168kg per strip.
- Roof sheets weigh between 85kg and 105kg and these were Code 7.
- Code 7 and Code 9 is a terminology used in the trade, which means code 9 is 9lbs per sq foot and Code 7 means 7 lbs per sq foot.
